# The Grounding of a Cruise Ship

*A lesson in maritime management.*

by Ms. KRISTE STROMBERG  
Special Correspondent to *Proceedings*

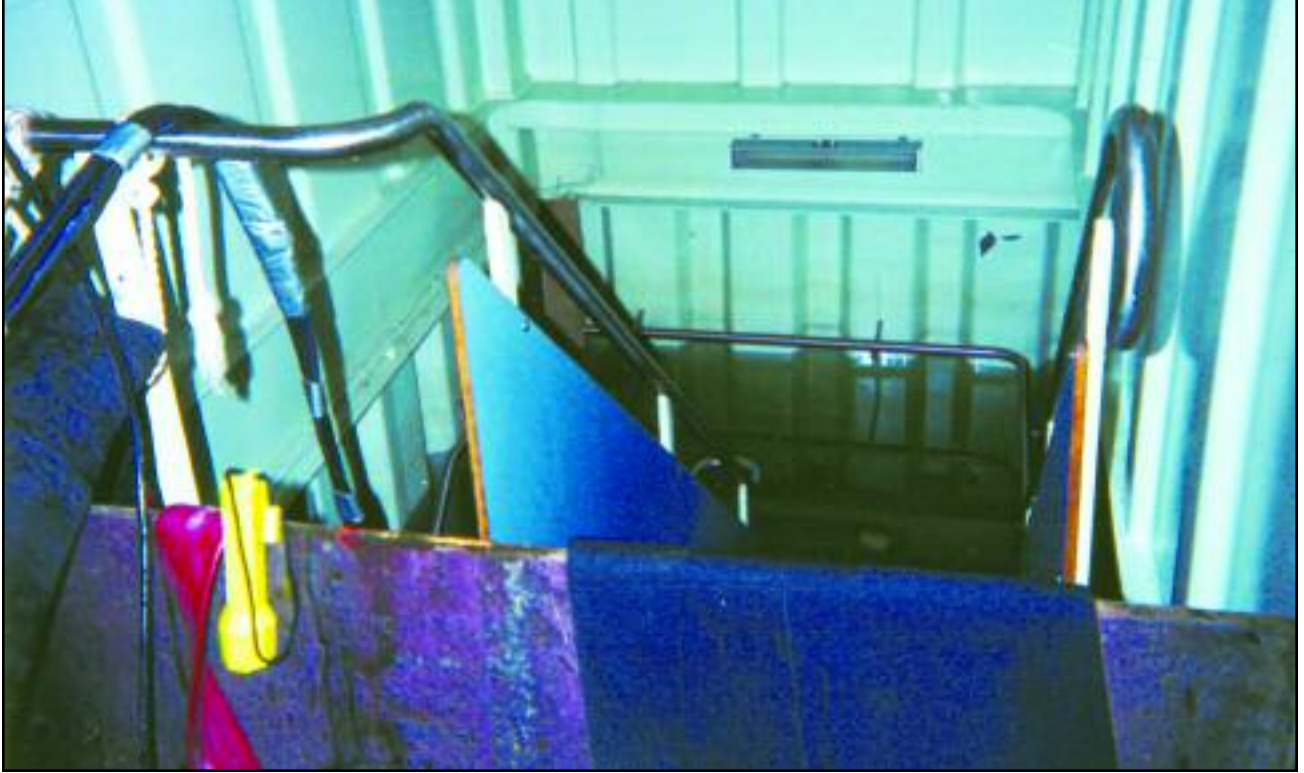
**Figure 1: A shot of an interior stairway, showing water level. USCG photo.**

As soon as he felt the ship vibrate from contact with the reef, the master returned to the bridge and assumed the watch of the ship. At about 1:35 a.m. all of the watertight doors were ordered closed to prevent further flooding throughout the ship (Figure 1). Watertight door number 10 was later found open by the ship's safety officer and was then closed. After consultation with the senior officers and Marine Operations in Miami, the master decided to ground the vessel on a sand bank in Great Bay in St. Maarten.

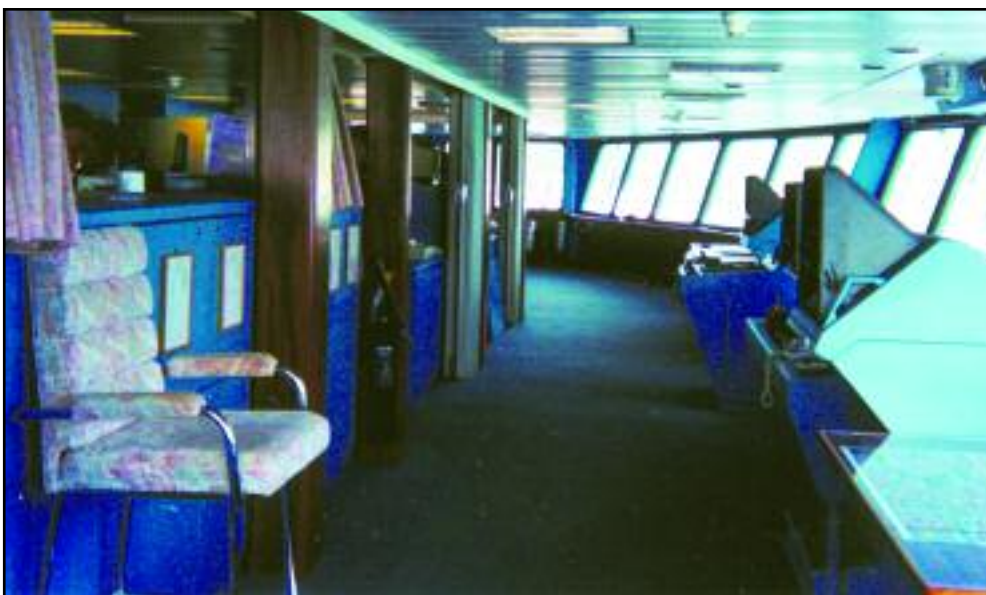
**Figure 2: The bridge layout on the *Monarch of the Seas* may have contributed to the incident. USCG photo.**

This was combined with a poor layout of the navigation station, which made it much more difficult to watch and use the ARPA as well as the other navigational aids aboard the vessel, such as the GPS receiver. The chart table was placed well away from the automatic radar plotting aid, which was at the forward starboard side of the bridge. While this position for the ARPA allowed a good view of any traffic on the burdened or starboard side of the ship, unfortunately, all other navigation instruments and the charts were located aft and well away from that position (Figure 2). This required the navigational watch officer to physically move around the chart table to the rear and away from the automatic radar plotting aid.

- The company should require all navigational watch officers to attend ARPA certification and periodic refresher training.
- The company should develop a brief, in-house ARPA training refresher course on training aids that navigational watch officers must successfully complete on an annual basis, or when first assigned to a particular vessel.
- For each vessel owned and operated by the company, personnel should examine the physical bridge layout and work with the vessel's navigational watch officers to modify the design to permit the most effective, efficient, and safe navigation of the vessel. This examination should take into consideration locating navigation charts and plotting tools as well as electronic navigation instruments readout in close proximity to the primary navigating station.

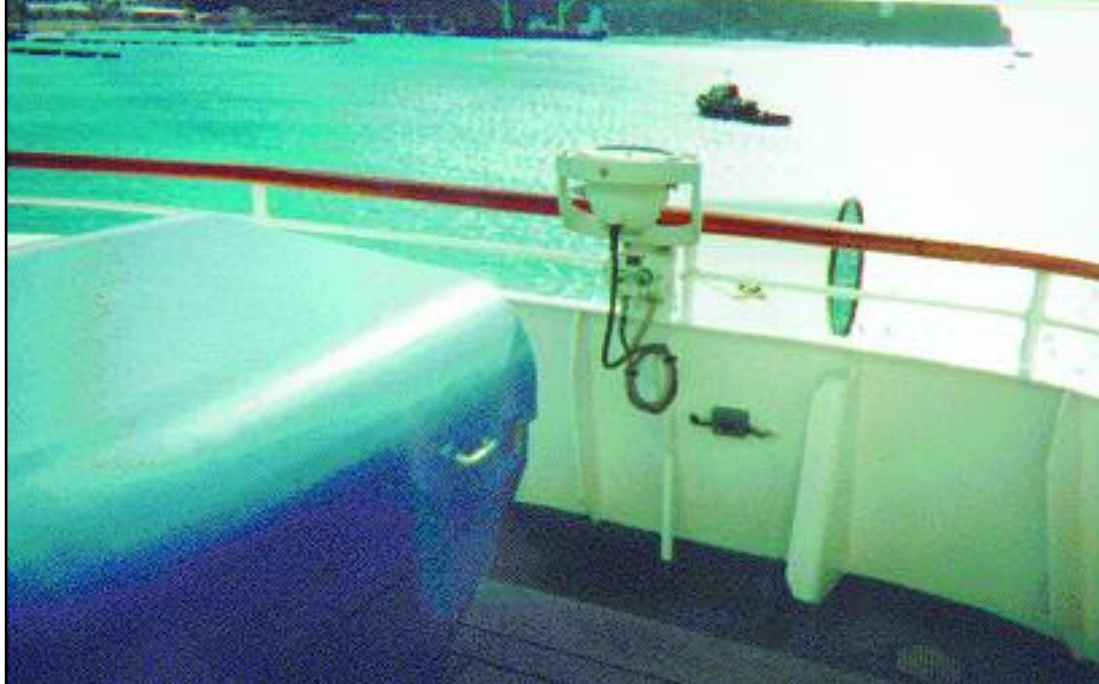
of the azimuth bearing circles on the gyro repeaters (Figure 3), taking several bearings, and then plotting them on a chart. On this vessel, this was made more difficult by the physical layout of the ship. The gyro compass repeaters were blocked by equipment cowlings that allowed only minimal physical clearance. It was no small wonder to the investigators that the navigation watchstander did not use this method to verify the ship's position at any time.

**Figure 3: The exterior starboard bridging repeater. USCG photo.**
